Storm Sewer Survey Phase 1

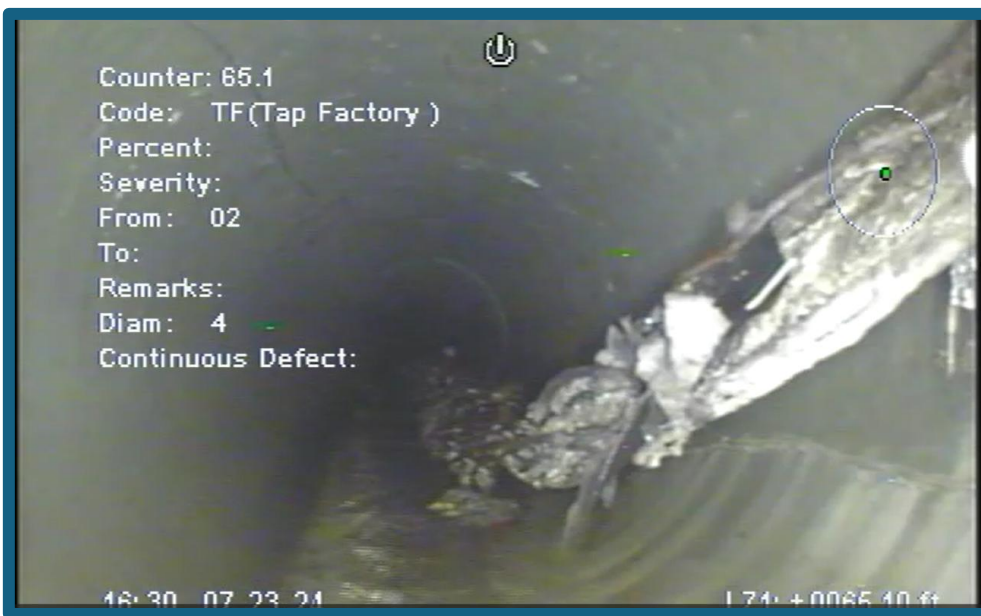
Photo 1 – Tree Root Intrusion

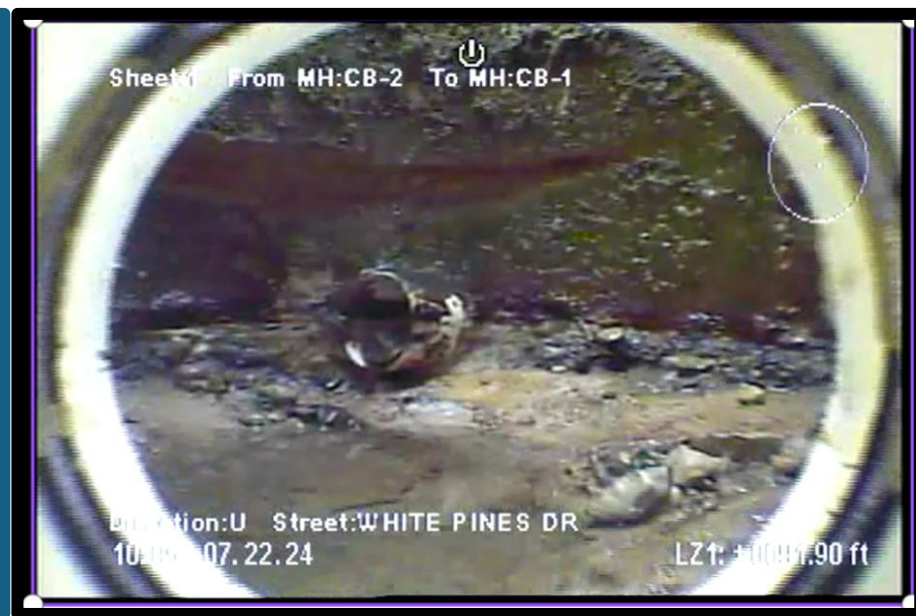
Photo 2 – Storm Drain Filled w/Sediment
